Attic to Sidewalk Home Inspection

Page 1 of 27
SampleInspectionReport

Others Present Property Occupied Vacant
Estimated Age 35 years Entrance Faces Street
Inspection Date October 21, 2006
Start Time 9:00 am End Time 12:15 pm
Electric On Yes
Gas/Oil On Yes
Water On Yes
Temperature 62 degrees
Weather Sunny Soil Conditions Damp
Space Below Grade Basement, Crawl Space
Building Type Single family, Two story Garage Attached

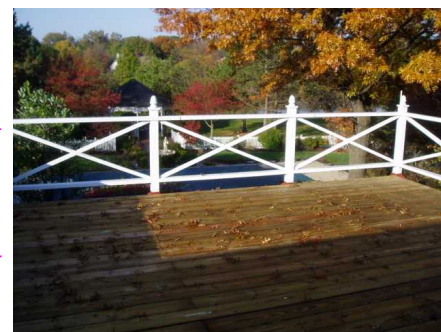
Acceptable Balcony: Treated wood over the sun room New wood flooring has been installed over the flat roof of the sun room. The surface of the roof cannot be seen. If repairs are needed the flooring will have to be removed.

The baluster openings are wider than are considered safe at this time. We recommend that the openings be no wider than four inches for safety.

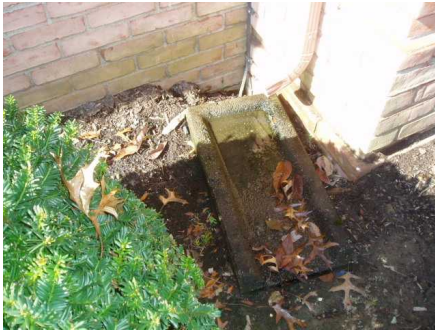
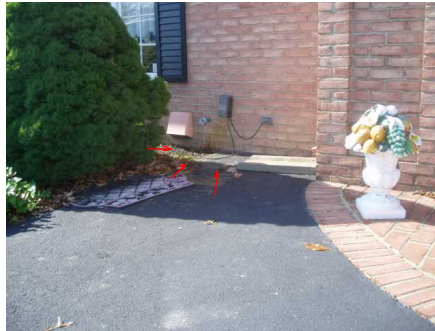
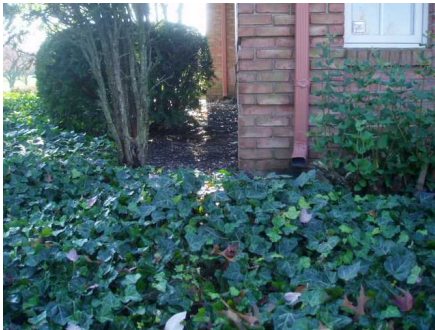
Grading: Negative slope toward the foundation in some locations. Soil sloping or erosion towards foundation was found at the right, front, and rear. This is called negative slope. I recommend the addition of fill dirt to improve grade to prevent water flow toward the foundation. If the areas are not graded away from the foundation, ground water could enter the foundation walls and allow mold growth, wet basements, or bowed walls which could require professional repairs. If positive slope cannot be established an area drain to a ditch, storm sewer, or drain line should be considered.

- > When negative grade is noted around the foundation, we recommend that a clay based dirt be added to drain water away from the foundation 4-5 feet with a 5 inch slope. At that time, the mulch can be replaced and any landscaping that is desired.

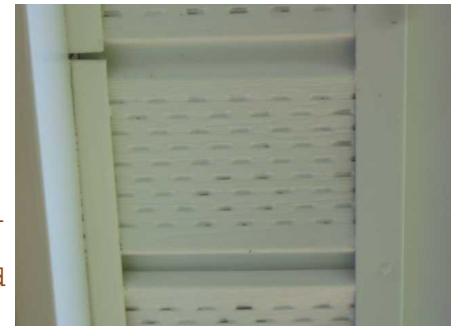
Soffits: Vinyl The Soffit vents are partially painted closed which reduces the amount of air present to vent the attic space. The vent area should NEVER be reduces as it increase the potential for excessive moisture conditions which can result in wood decay or mold growth. The vinyl Soffit was installed over the original wood Soffit which had screens cut in the surface. These original screens may have allowed the squirrel entry into the attic.

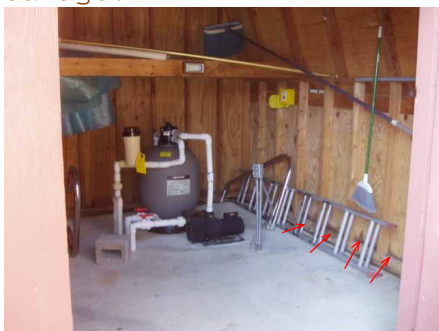
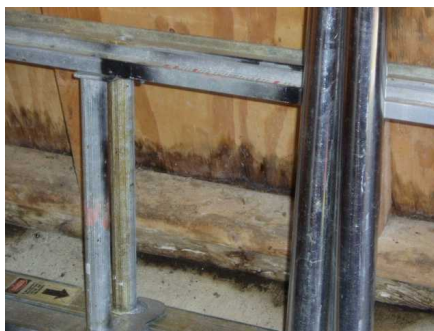
Left side, Rear Outbuilding

Improve **Exterior Surface:** Wood sheet siding The bottom edges are decayed. I suggest they be replaced as needed and the edges be kept well sealed to prevent water entry. The shed is useable but should be repaired to prevent future damage.

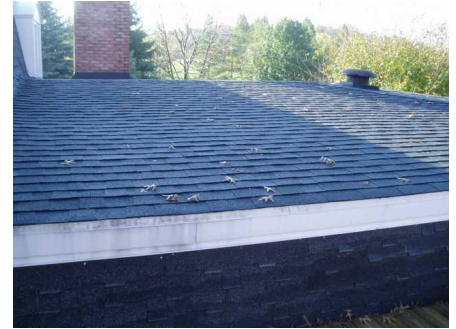
Material: Asphalt shingle Asphalt shingles are NOT RECOMMENDED for roof surfaces with less than a 3/12 pitch. Flat or shallow roof surfaces require rolled asphalt or rubber surfaces to remain watertight. A qualified roofing contractor is recommended to evaluate, estimate, and perform repairs.

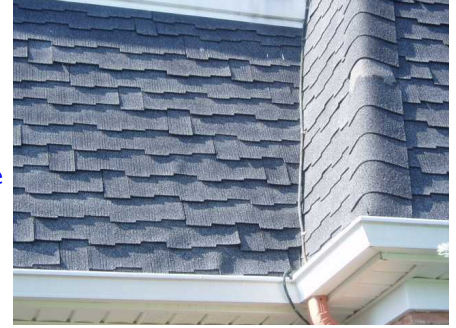
Material: Asphalt shingle The shingles on the mansard sides are beginning to curl. No less than one of the corner shingles is missing. Consideration should be given toward replacing the mansard shingles before a major leak develops. Signs of prior leaks were found on the sheathing during the inspection of the attic.

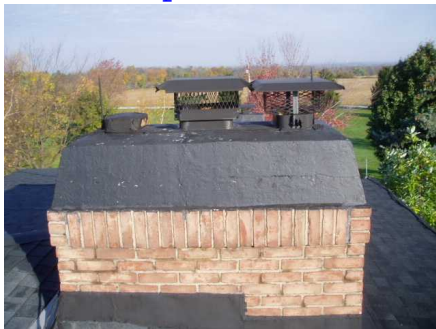
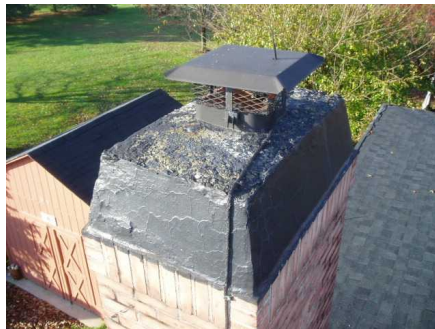
Flue/Flue Cap: Clay flue tile, Concrete cap, Metal hat The sides and tops of the caps have been coated with asphalt which dries and cracks with age. It should be re-sealed soon to prevent water entry into the concrete cap. Asphalt is considered a temporary sealant. It will have to be re-done in the future. A permanent repair by a qualified contractor would be a better repair.

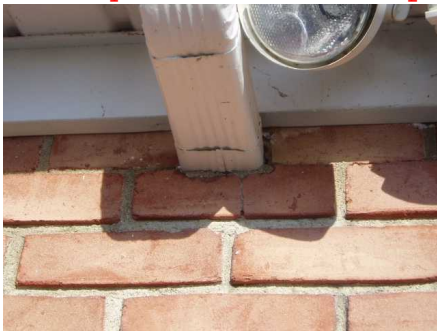
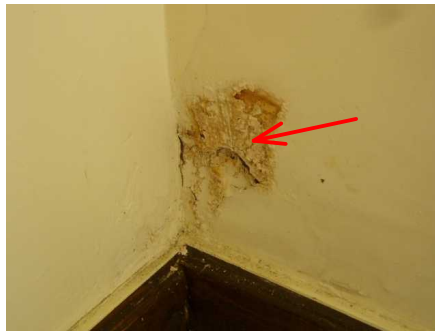
Defective Downspouts: Aluminum and ??? The garage downspouts disappear into the garage wall through the brick on the ends. There is a leak in the front downspout somewhere inside the wall. The drywall is water damaged at the bottom and had been painted before. A qualified contractor should remove the drywall and make repairs as needed before the section is finished.

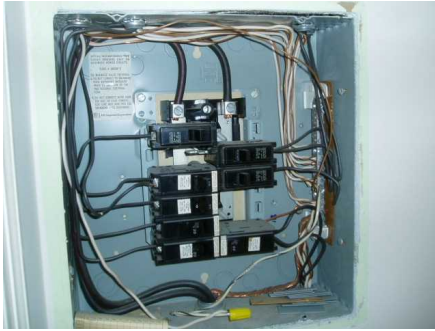
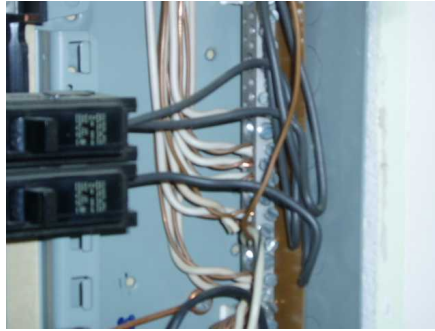
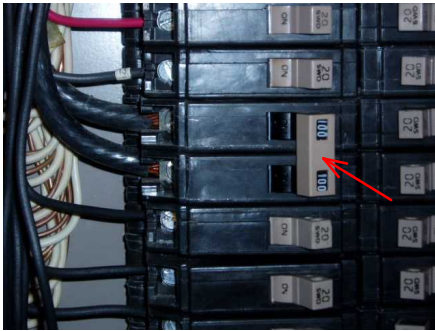
Manufacturer: Murray This is a three wire sub-panel in the upper closet. The 110 AMP breaker in the basement panel supplies the panel. A cable with only three wires in it carries power between the main electrical panel in the house and the small panel in the garage. Though commonly done when this house was built, it was wrong then and it's still wrong today. With only three wires connecting the panels, the electricity may flow back to the service panel via bare ground wires, equipment enclosures, metal piping systems or other surfaces where people can touch it. Under certain rare conditions they might be shocked. If you want to improve the safety of these panels, have your electrician re-connect them to each other with a cable that has four wires. This way, he can wire the panels in such a way as to keep electricity from flowing over the grounded surfaces and there's less chance that people could be shocked. National Electric Code 250-24a5, 250-142b, 384-20.

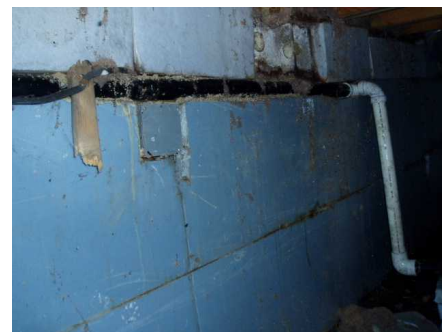
Acceptable Structure Type: Wood frame
Acceptable Foundation: Masonry
Acceptable Beams: Steel I-Beam
Acceptable Bearing Walls: Block, Frame
Acceptable Joists/Trusses: 2x10 16" on center
Defective WDI insects Carpenter ants Carpenter ants bodies were found in the basement and the crawl space. Treatment is recommended.

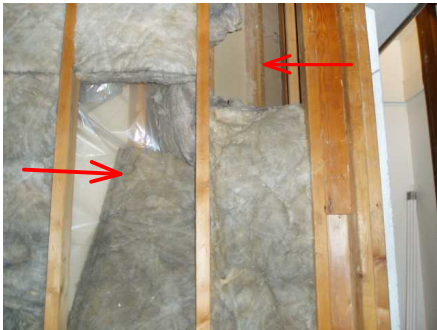
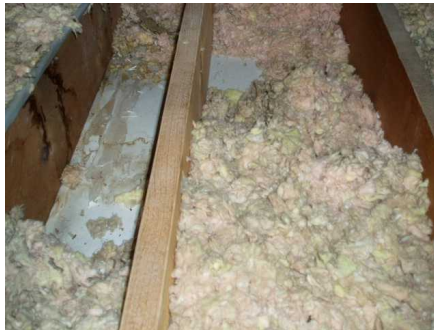
Insulation Depth: 7' " The insulation has been disturbed and there are areas with little or no insulation. The insulation should be distributed evenly in the attic. An insufficient amount of insulation is present for current applications. Consider adding un-faced or loose insulation on top of the existing insulation in the attic to conserve energy. The "Department of Energy" recommends that additional insulation be installed to increase the depth to a minimum of 12 inches or a "R" value of 35 - 40. Be careful not to cover the Soffit vents.

The insulation on the right wall at the access HAS FALLEN. The insulation should be replaced after a means of supporting it is installed.

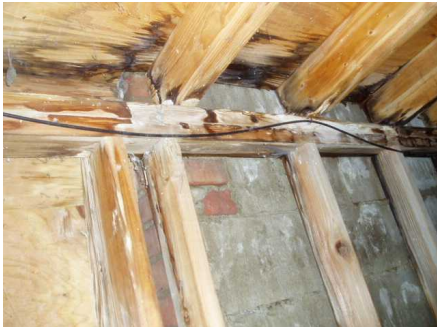
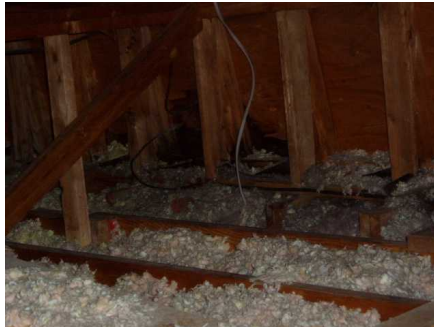
Moisture Penetration: Previous water penetration noted Old water stains were noted at the plywood on the lower mansard sides of the attic. The water entry appears to be old. Repair of the plywood may be needed when the mansard shingles are replaced.

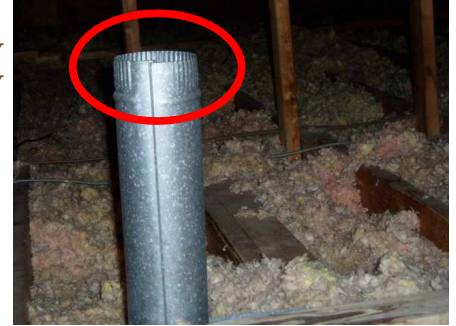
Bathroom Fan Venting: Electric fan into the attic
The bathrooms improperly vent into attic and may cause moisture damage to the insulation or decay in the sheathing. I recommend that the vent lines be extended to the exterior.

2000 Mechanical Code: 501.3 Outdoor discharge. The air removed by every mechanical exhaust system shall be discharged outdoors at a point where it will not cause a nuisance and from which it cannot again be readily drawn in by a ventilating system. Air shall not be exhausted into an attic or crawl space.

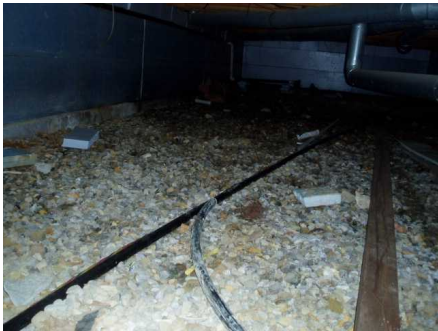
Acceptable	Access: Open
Acceptable	Ventilation: Crawl space opening
Acceptable	Insulation: Fiberglass
Not Present	Vapor Barrier: None There is no vapor barrier on the crawl space floor. A heavy plastic sheeting should be carefully installed to prevent moisture entry into the crawl space.

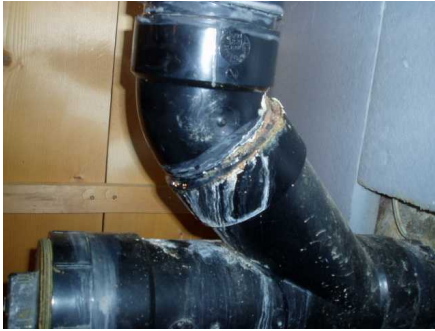
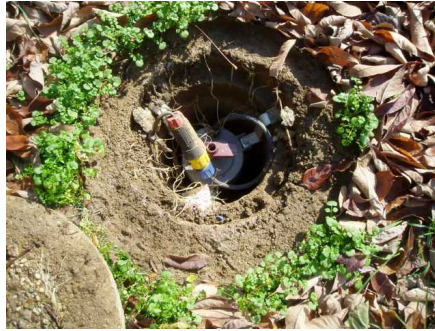
Drain Pipes: ABS There is a leak in the main drain-line at the rear of the basement. Repairs by a licensed plumber are recommended.

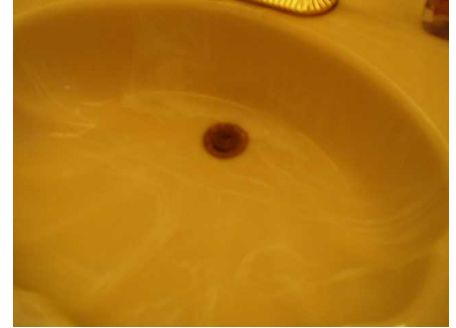
Faucets/Traps: Slow draining Slow draining and disconnected drain rod were noted-further review/repair as needed.

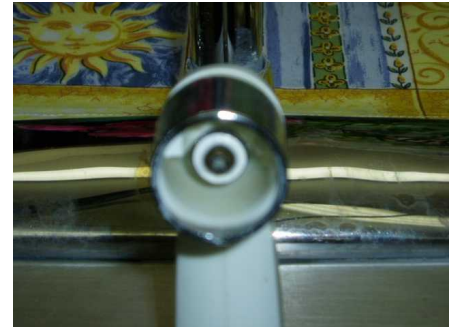
Acceptable	Refrigerator: Frigidaire
Acceptable	Microwave: Amana
Acceptable	Sink: Stainless Steel
Acceptable	Electrical: 110 VAC outlets and lighting circuits
Improve	Plumbing/Fixtures: Functional The spray nozzle for the sink is missing some parts. Replacement or repair is recommended.

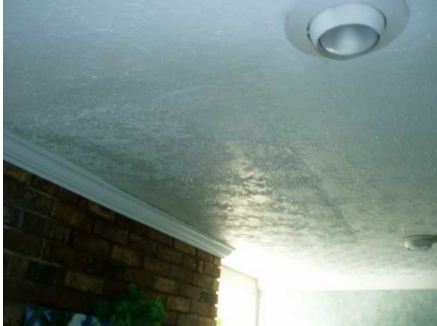
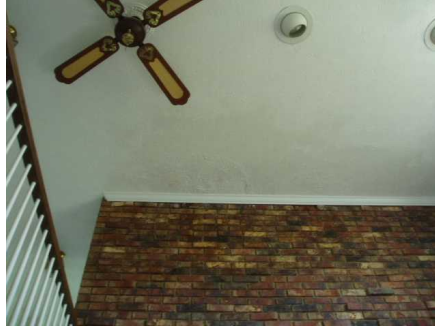
Light could be seen through the mansard roof at the right chimney from the attic at the rear of the chimney and may be allowing water entry to the interior. A qualified contractor should make repairs as needed to prevent water entry.

Ceiling: Textured drywall Repairs have been made to the drywall ceilings at the face of all of the chimneys. The water entry was from leaking flashing of the chimneys at the roof. This appears to have happened before the new roof surface was installed. Ask the owner about these damaged areas and repairs. SEE ROOF SECTION. CHIMNEY.

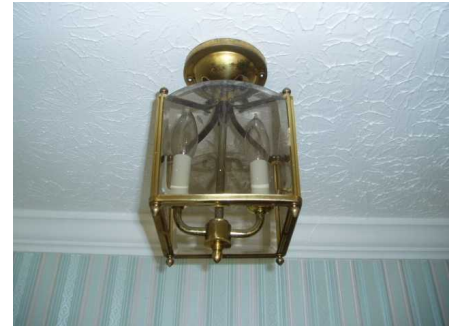
Electrical: 110 VAC outlets and lighting circuits
There are several switches and switch clusters that I could not determine what they were connected to or if they are presently in use. Some of them may go to fixtures that have bad bulbs. Some of the switches may be for exterior lighting which could not be determined during the day. An electrician should examine the circuits to make this determination.
