Attic to Sidewalk Home Inspection

Page 1 of 27
SampleInspectionReport

Others Present Property Occupied Vacant
Estimated Age 35 years Entrance Faces Street
Inspection Date October 21, 2006
Start Time 9:00 am End Time 12:15 pm
Electric On Yes
Gas/Oil On Yes
Water On Yes
Temperature 62 degrees
Weather Sunny Soil Conditions Damp
Space Below Grade Basement, Crawl Space
Building Type Single family, Two story Garage Attached

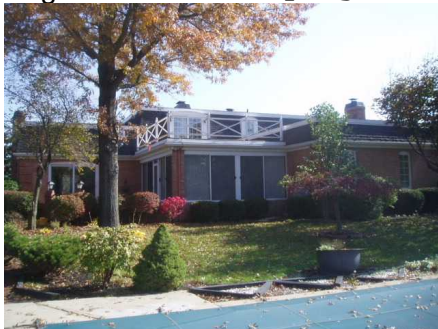
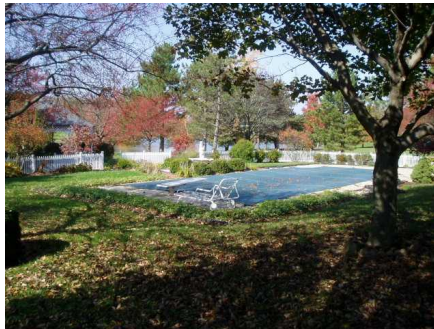
Grading: Negative slope toward the foundation in some locations. Soil sloping or erosion towards foundation was found at the right, front, and rear. This is called negative slope. I recommend the addition of fill dirt to improve grade to prevent water flow toward the foundation. If the areas are not graded away from the foundation, ground water could enter the foundation walls and allow mold growth, wet basements, or bowed walls which could require professional repairs. If positive slope cannot be established an area drain to a ditch, storm sewer, or drain line should be considered.

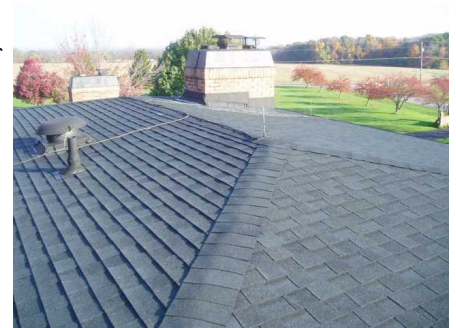
Material: Asphalt shingle I found no issues with the roof surface. The normal life expectancy for this type of shingle is 20 - 25 years.

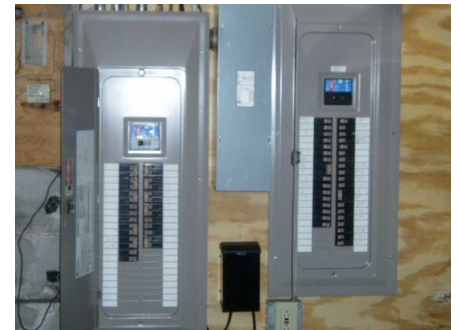
Basement Electric Panel

Acceptable Manufacturer: Cutler-Hammer I find no issues with the electric panel.

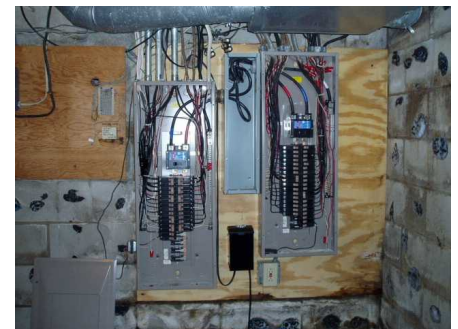
Basement Electric Panel

Acceptable Manufacturer: Cutler-Hammer I find no issues with the electric panel. There are additional spaces in the electric panel that could be used for expansion of the electrical circuits.

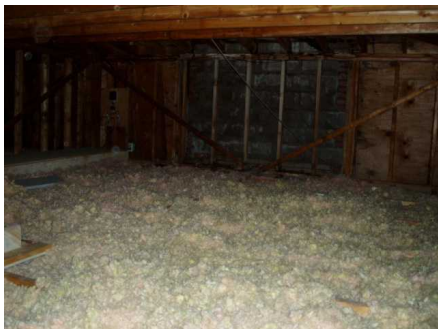
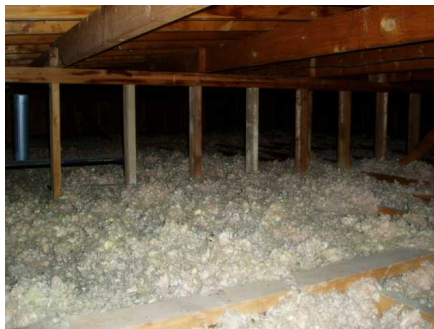
Acceptable Unable to Inspect: 10% The insulation in the attic prevents an inspection of the bottom of the roof framing and any plumbing, electric, or vents under the insulation.

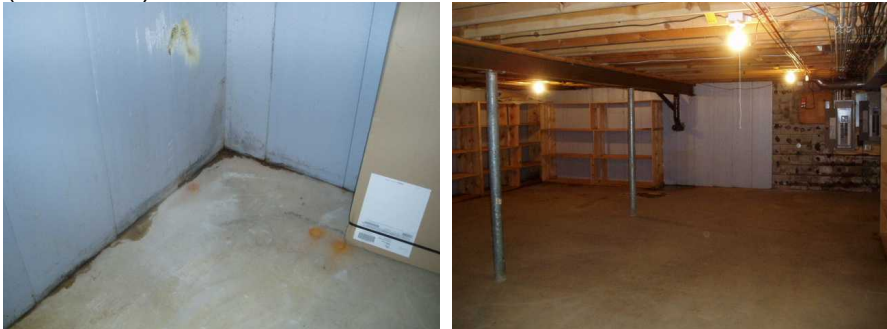
Moisture Location: (continued)

Acceptable	Floor: Concrete Cracking of concrete floors is very common and normal unless the cracks are more than 1/4" wide and there is differential settlement.
Acceptable	Electrical: 110 VAC outlets and lighting circuits
Acceptable	HVAC Source: Air exchange ventilation
Acceptable	Insulation: Fiberglass on the bandboard
Defective	Moisture Location: Front left corner Water stains and dampness on the floor was found at the front left corner. I am not able to determine the condition of the walls beneath the form insulation. 75% of water entry into foundation walls has been found to be caused by improper grading or defective gutter/drainage systems. SEE LOTS AND GROUNDS SECTION.

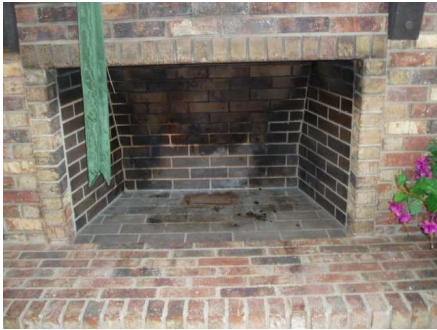
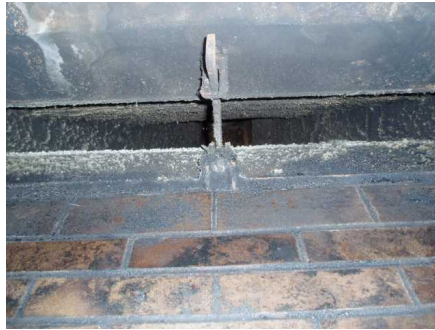
Acceptable	Flue: Clay tile We conduit a limited "Phase I" inspection of all fireplaces. Our view of the fireplace flue and upper fire chamber is very limited. The interior of the rear center chimney damper is covered with creosote which prevents an inspection of the surface of the flue material.. Although there were no apparent problems found during this inspection, I strongly recommend that a "Phase II" inspection with a remote camera be conducted after cleaning the interior of the fireplace chambers and flue.
------------	---

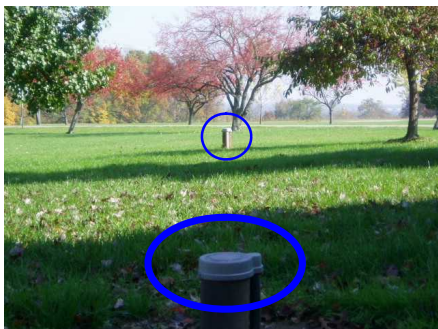
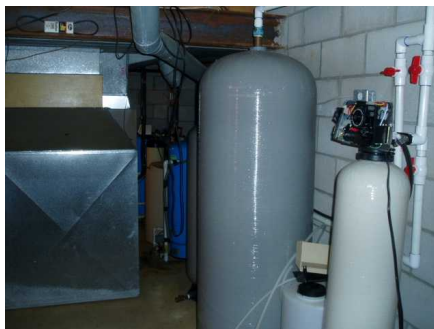
Acceptable **Service Line:** Plastic to the pressure tanks This house has a well water system with a pressure tank which is located in the basement. The rear tank and well are not connected. The well casing is located in the right yard. The active well is closer to the road. Additional inspections for water quality, quantity, and verification of the water treatment systems are recommended.
